Abstract

SPARK EROSION ON MAIN BEARINGS

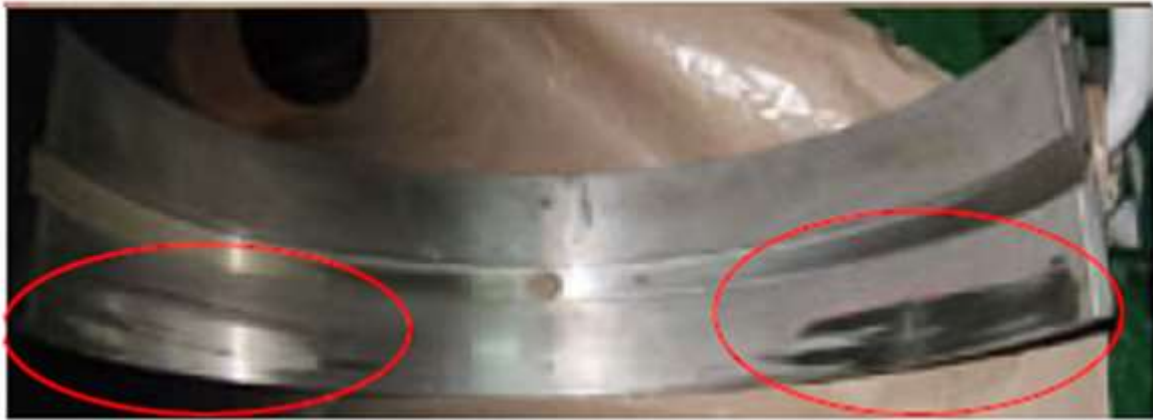
This is a journal, main bearings (AlSn40 Lining) and thrust collar with clear signs of spark erosion. Spark erosion signs are obvious, even in the upper main bearing shell. The bearing damage is irreparable, cannot be re-used and it has to be replaced.

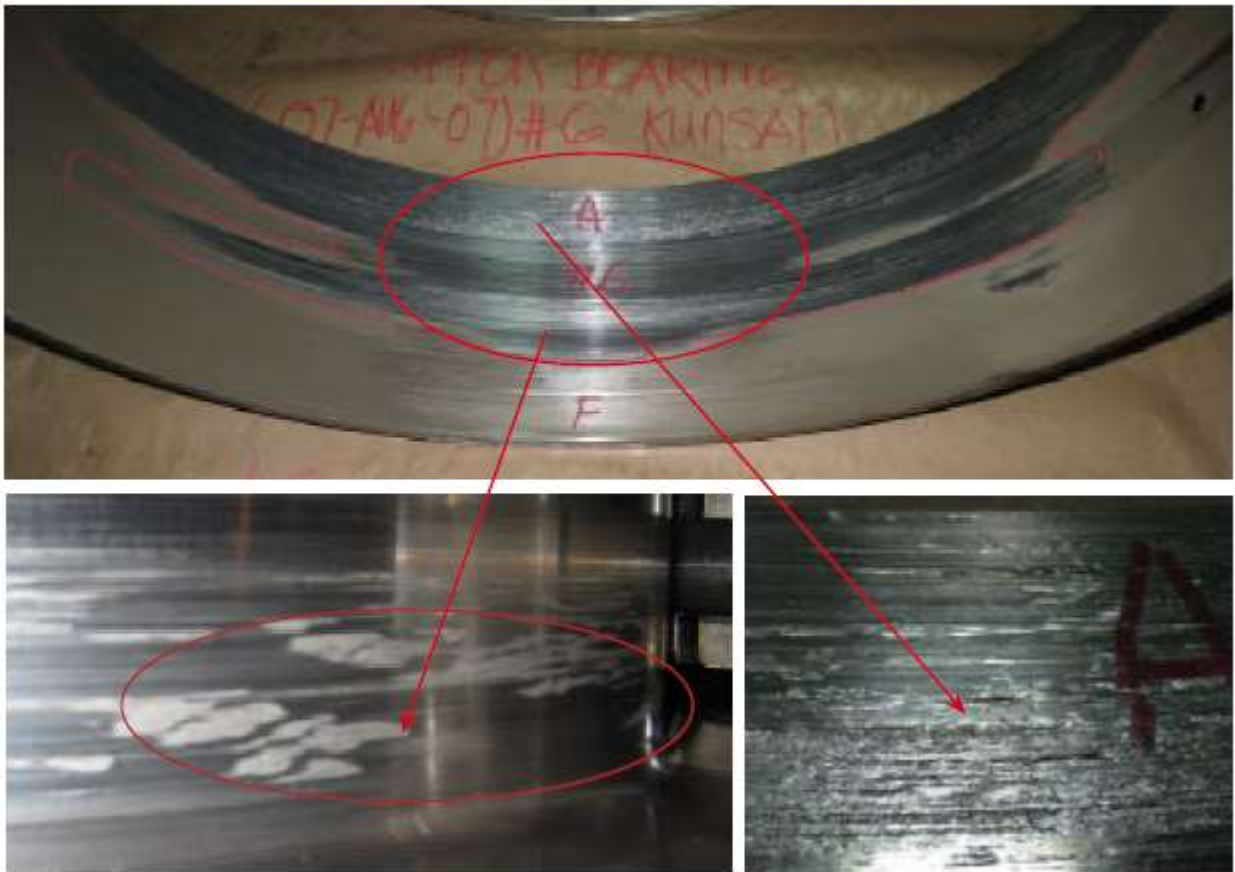
Upper main bearing shell with signs of spark erosion

The journal must be polished to meet surface roughness specifications

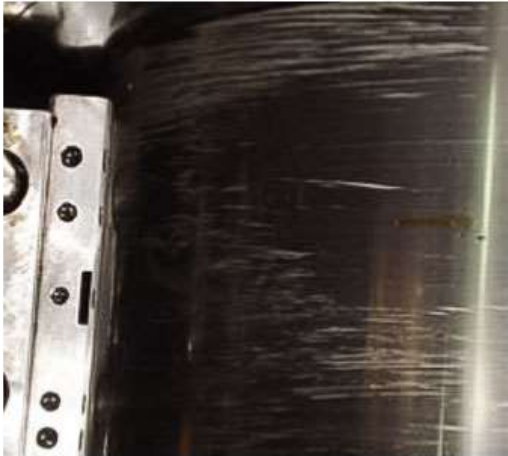
Below there is a main bearing with moderate spark erosion, discovered in time to save the bearing shell. This bearing can be re-used after dressing up. The journal must be polished to meet surface roughness specifications.

Corresponding lower bearing shell. Visible spark erosion, but no or limited wear can be measured.
